I Crewman Received 440V Electric Shock

2 Near Miss: Improper Use of Fall-Arrest Equipment Leads to Fall

3 Failure of Hose Reel Bearing Housing

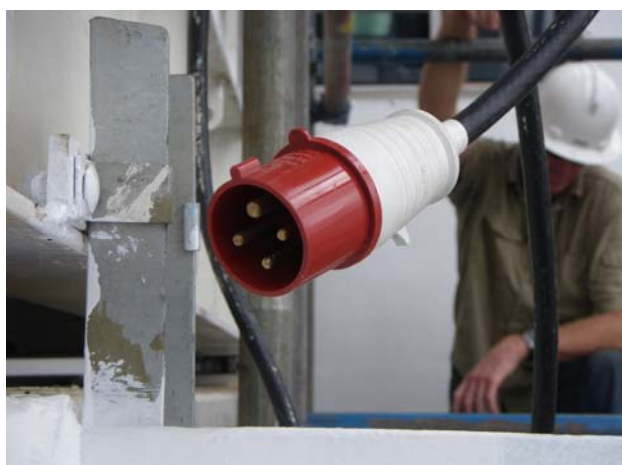
- ◆ The electrical works including commissioning for electrical systems on the TLQs were already completed;
- ◆ Following this, the supply lead had been removed from the socket but the supply had not been isolated;
- ◆ The electrician was called to investigate why there was no power in the TLQs;
- ◆ There were a large number of sub-contractors working on the installation at the time of the incident;
- ◆ The 440V power supply was not isolated from the main switchboard prior to connection;
- ◆ TLQs were supplied with female sockets which resulted in the extension cable having a live male end.

Male socket

- ◆ The sockets on the three TLQs on board the installation were changed for male sockets such that the live supply wires have safer female plugs;
- ◆ The manufacturer of the TLQs was informed of this potentially hazardous arrangement of power supply sockets;
- ◆ The importance of rigorous lock-out tag out procedures was reinforced to crew and fleet.

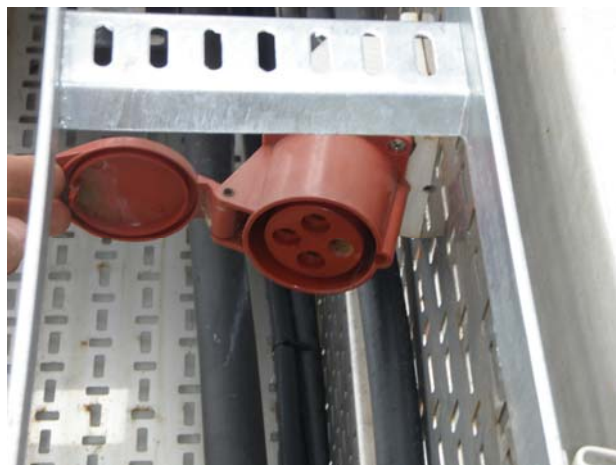
Female socket

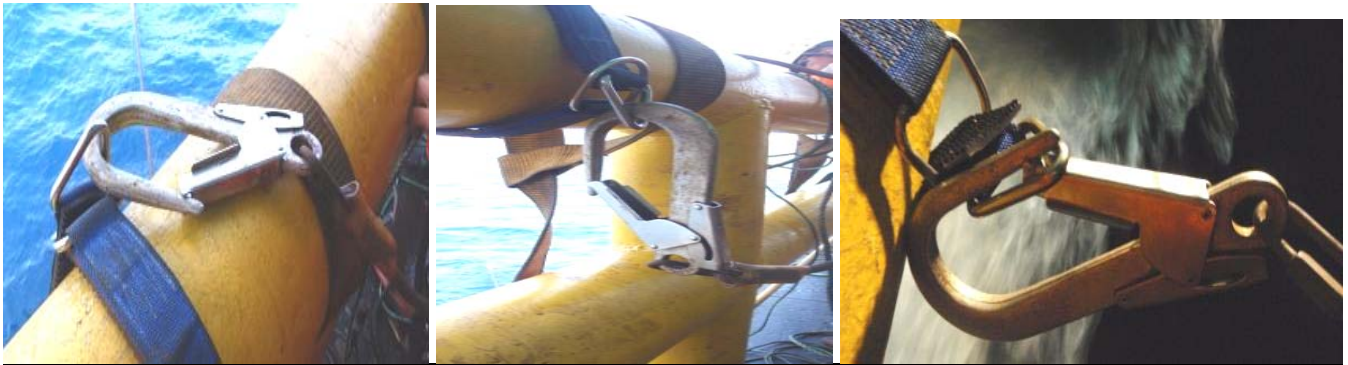
- ◆ An incompatible strop/connector was selected and used as an attachment point (choked around outboard railing). This should not have been permitted;
- ◆ The rigger did not check the double action connection was engaged and under vertical tension prior to descending into position;
- ◆ There was no dedicated spotter;
- ◆ The lanyard connector and anchor point set up enabled 'roll out' to occur through side loading on the primary locking device;
- ◆ No secondary safety line was used.

- ◆ The type of strop and descending device was changed out before work continued;
- ◆ Personnel were briefed on principles of 'dynamic roll-out' and the correct selection of rope access, anchorage points and fall restraint equipment;
- ◆ Specialist equipment for 'over the side' work should be purchased as a matched set, clearly identified, inspected and kept together at all times for specific 'over the side' tasks;
- ◆ Working at heights awareness training should be a prerequisite for any task requiring the use of fall restraint equipment. Training in rescue equipment and techniques should also be a minimum standard for spotters.

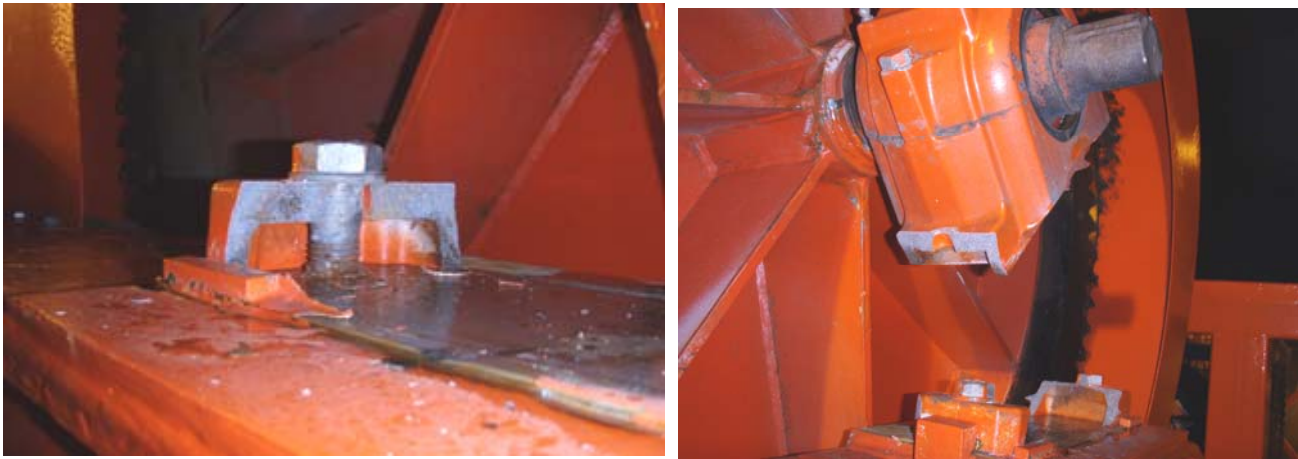
A member has reported a serious failure of a shaft bearing housing on a hydraulic winch rented from a third-party contractor. During recovery of a load from the seabed, the shaft bearing housing broke. The winch wire raced out 2-3 metres before the drum got stuck in the casing and stopped rotating. The 'fail-safe' brakes of the winch did not engage when

- ◆ A laboratory test revealed that the winch had been exposed to repetitive overload prior to being taken onboard the company’s vessel, causing cracks in the bearing housing to develop over time;

- ◆ During preparation of the winch prior to mobilisation on the vessel, the certification body required a reinforcement of the winch frame at the motor side. This could have been an indication that the winch frame had been sagging at the motor side (where the bearing housing broke) which may have contributed to the damage;

- ◆ If the winch, with the spooling device fitted, had been exposed to loads up to its SWL and additionally been load tested to SWL x 1.1, this would have significantly increased the risk of damaging the shaft bearing housings and explains the low cycle fatigue damage of the axle bearing housings;

- ◆ Establish procedures for NDT of all load bearing parts as part of routine maintenance and/or mobilisation checks for winches and other lifting appliances;

- ◆ For future lifting operations the company recommended that such winches should not be used without a proper drum disk brake, since there was no proper second barrier for safety. This was also noted to be the recommendation in the DNV lifting Appliances Rules section 5 B306.

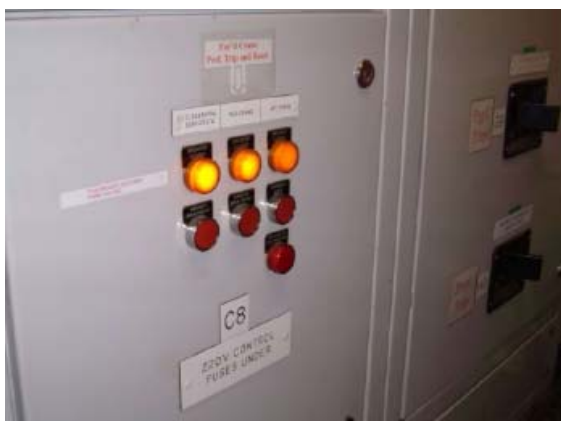
Switchboard open/reset command buttons

- labelling explaining the function of the breaker command buttons (open/reset) on the switchboard was not sufficiently explicit and was open to interpretation

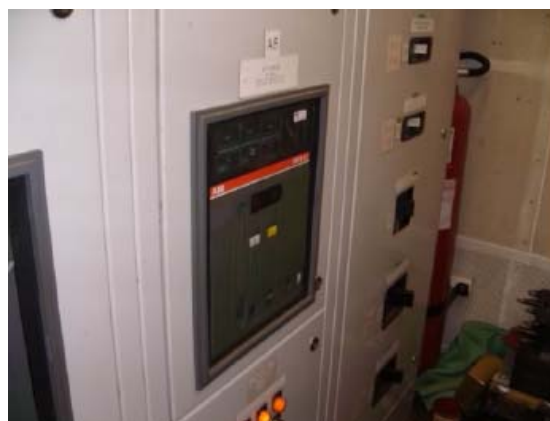
Switchboard crane breaker

- the breaker status lights showed ‘orange’ (amber) as the normal operating condition. This was potentially confusing and should ideally be ‘green’ to reflect a more obvious normal operating condition

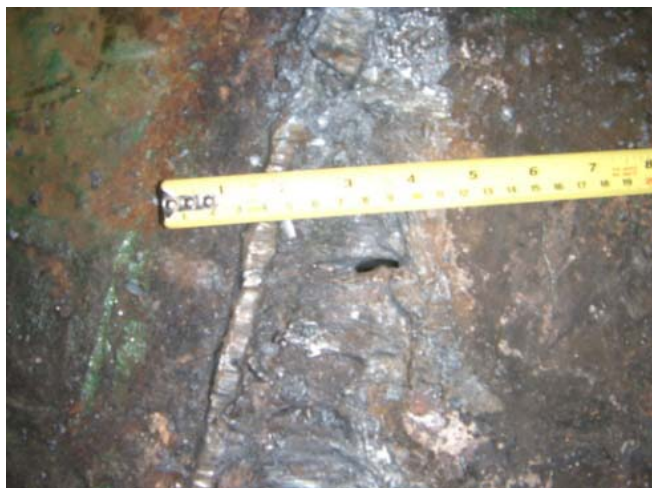
Hole burnt in deck

- ◆ The main contributory factor was failure to follow procedures:
 - the sub-contractor was fully aware of requirements imposed by the vessel and his own employer that sea fastenings should be burnt off 3mm above the deck. This requirement was not followed in this instance

- ◆ There was a momentary lapse in concentration allowing heat from the torch to penetrate the deck on the opposite side of the cleat being removed. The incident occurred less than two hours after a thirty minute break, and there was no pressure on the workers involved to hurry or rush the job;

- ◆ The burning torch angle should be maintained horizontal to the deck at all times during sea fastening removal. A relatively small deflection of +/- 5° could cause damage to the deck;

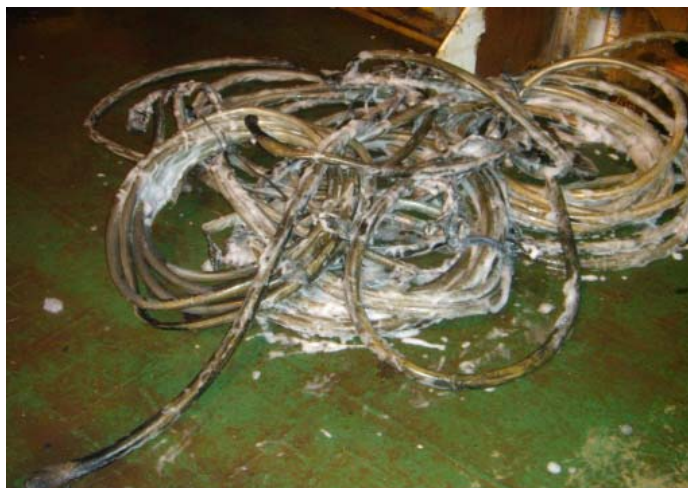
Damaged plastic hose in space underneath

The vessel fire and emergency procedures worked well and the incident was quickly and professionally contained within a few minutes. Upon investigation, it appears that the plastic hose may have been on fire due to damage it had sustained, but there was no damage to any other equipment within this space apart from superficial blackening of paint work.

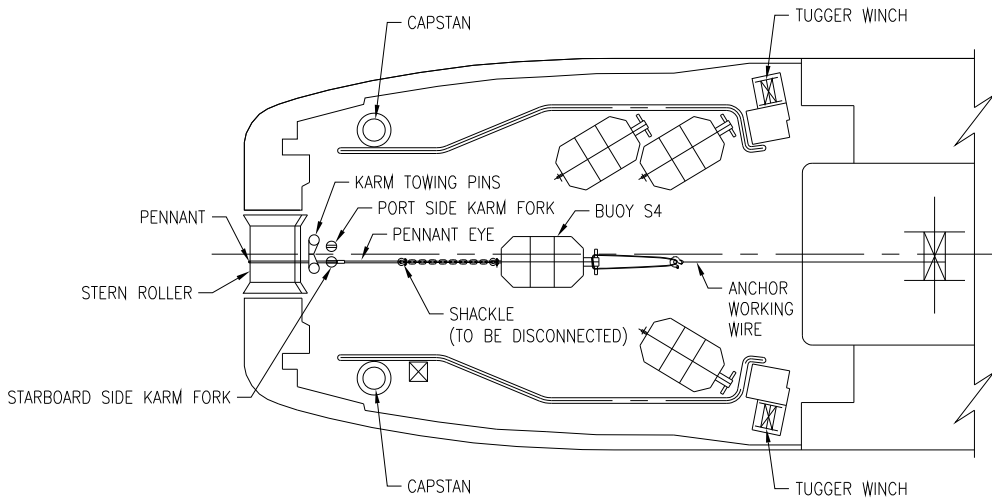
The anchor buoy was winched onto the deck of the AHT until the pennant was in the wire stopper used to prevent the buoy from being pulled back towards the stern by sudden tension on the pennant wire. (See Fig. 1 Step 1.) Two crew members were disconnecting a shackle between the pennant wire connected to an anchor on the seabed and the buoy on deck (See Fig. 1 Step 2), when suddenly the pennant wire came under tension. The wire stopper failed to stop the pennant wire effectively and the sudden tension on the pennant wire jerked the buoy towards the stern of the vessel. The two crew members who were busy disconnecting the shackle were struck by the moving buoy. (See Fig. 1 Step 3). One crew member died instantly, the other suffered a minor injury.

STEP 1. BUOY ON THE DECK

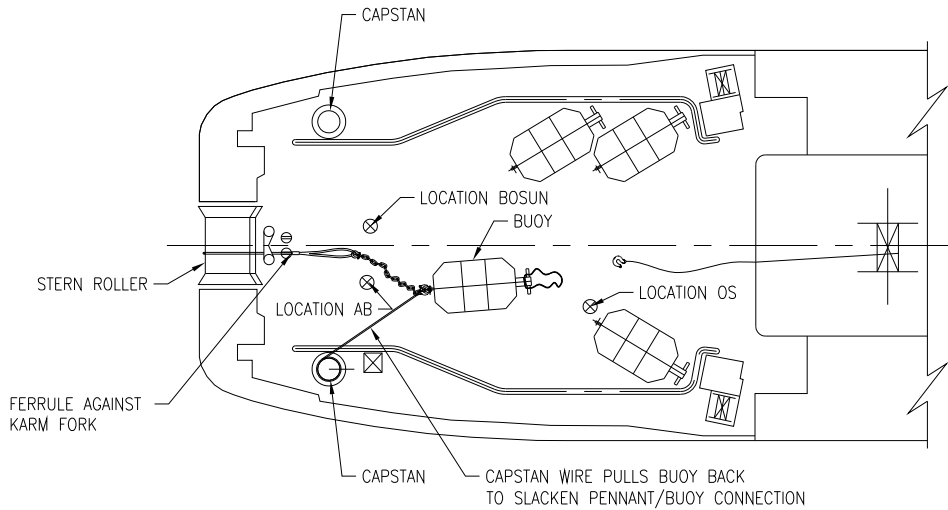
STEP 2. START DISCONNECTING

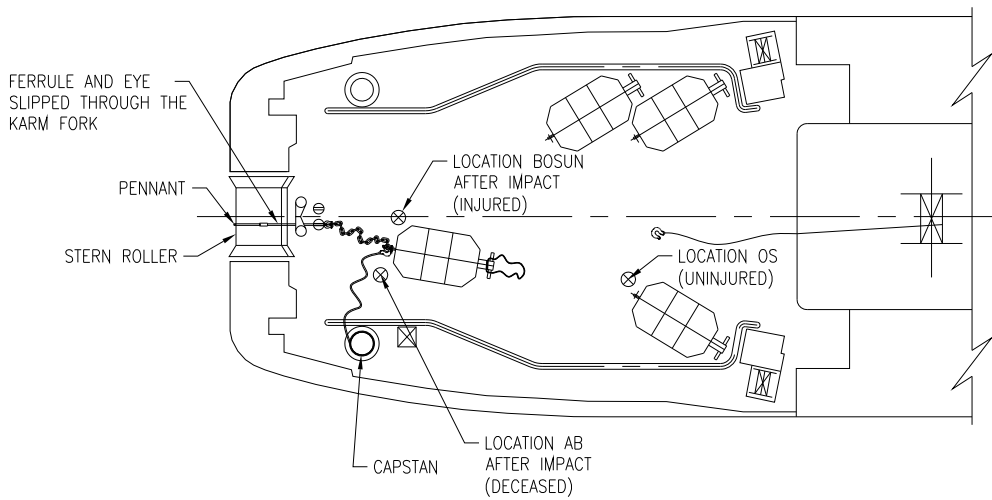
STEP 3. INCIDENT

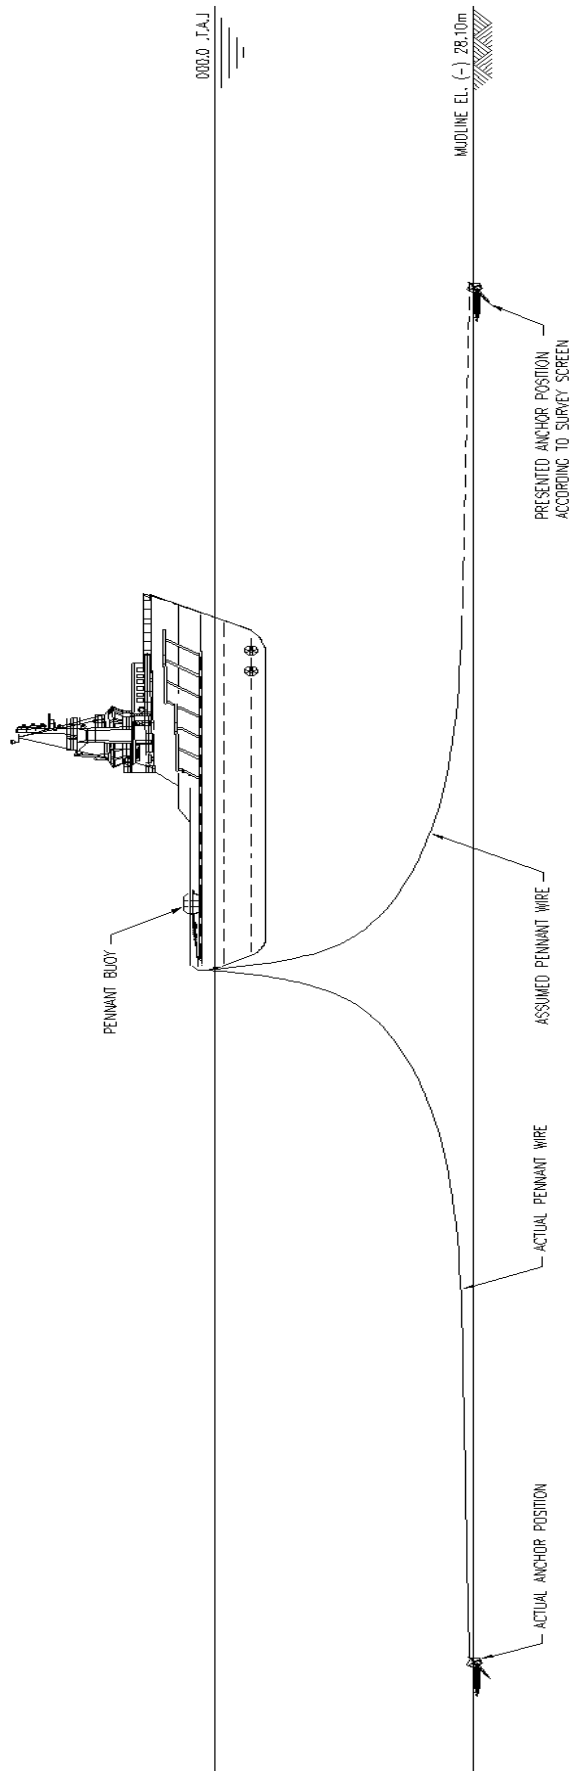
Fig. 2 Actual and design anchor positions

The sudden tension on the pennant wire came about because the survey screen on the bridge of the AHT displayed a 'design anchor position' instead of the 'as laid' anchor position. Based on the information presented by the survey screen, it was assumed that there was sailing slack in the pennant wire when in fact, it was being tensioned. (See Figure 2)

AHT MOVES FORWARD ASSUMING TO SLACKEN PENNANT WIRE BUT IN FACT TENSIONING IT

- ◆ A monthly inspection and check on wear and tear of the wire stopper equipment should be added to the vessel's planned maintenance system
- ◆ The 'as laid' information of the anchor should be provided by the positioning subcontractor and displayed on the survey screen

- ◆ The survey screen provided by the positioning subcontractor should be considered an additional tool to provide an assumed anchor location to the AHT, but this location should never be interpreted as representing the actual anchor position. A warning message to this effect should be displayed on the survey screen

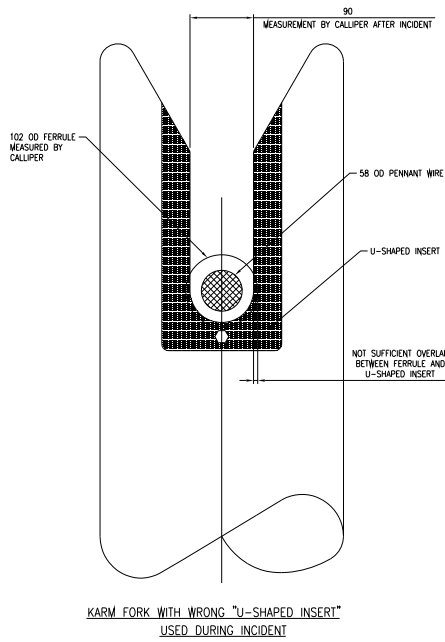
Our member conducted an investigation and the root cause of the incident was determined to be that the wire stopper failed to stop the pennant wire. This happened because an incorrect (oversized with respect to the diameter of the pennant wire) 'U-shaped insert' was mounted into the wire stopper. This 'U-shaped insert' also displayed excessive wear and tear. (See Figures 3 & 4) As a consequence of this the socket at the end of the pennant was able to pass through the wire stopper when the pennant wire came under tension.

Fig. 3 Incorrect "U-shaped insert"

- ◆ A thorough check of the wire stopper's exchangeable parts should be made to ensure that it is adequate to handle the actual pennant wire diameter, and this should be recorded

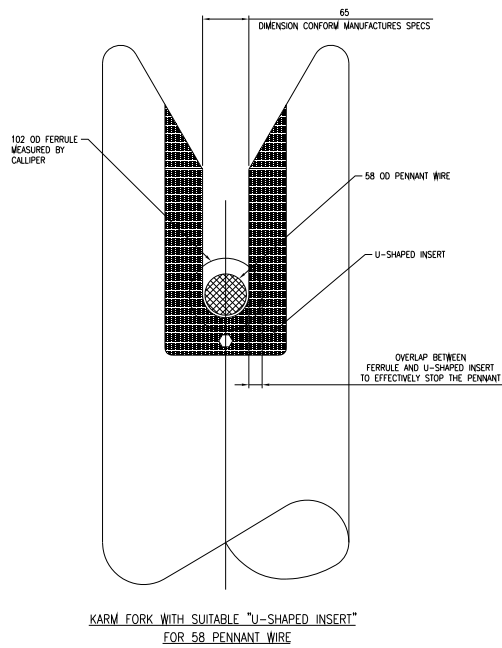
Fig. 4 Correct "U-shaped insert"
