Date: August 10, 2007

Fire During Flow Back Operations

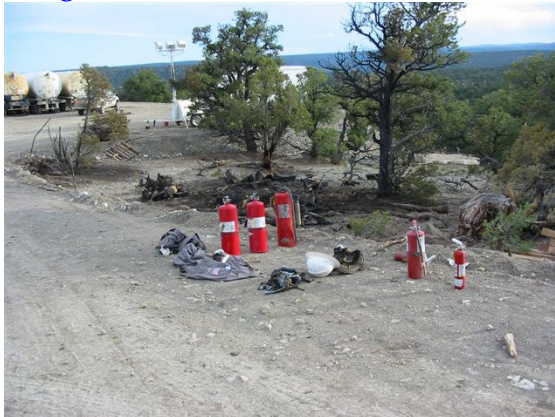
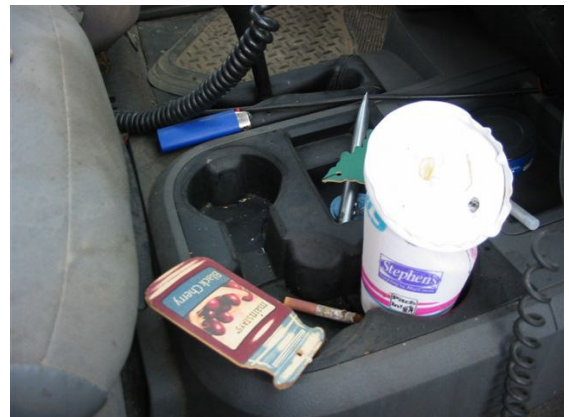
Gas from the well was not being disbursed into the atmosphere at a rate sufficient to eliminate the chance for ignition. Additionally, the test separator, sand trap and flare stack were not in use at the time of the incident.

1. No Smoking On Location Except in Designated Areas
2. If unable to flare well bore gases, equipment should be configured to ensure proper disbursement of gas into the atmosphere.
3. If wellsite activities can not be conducted with the proper equipment and procedures to ensure a safe worksite; wellsite activities should be suspended and management contacted.
4. All personnel should wear Fire Resistant Clothing (FRC's) when on a wellsite.
