# LEARNING FROM INCIDENTS ACTION ALERT

## Non Shell - Philips FR2+ AED RECALL

Alert #AA-NS-EPW-09-10-001

Issue Date: October 2009

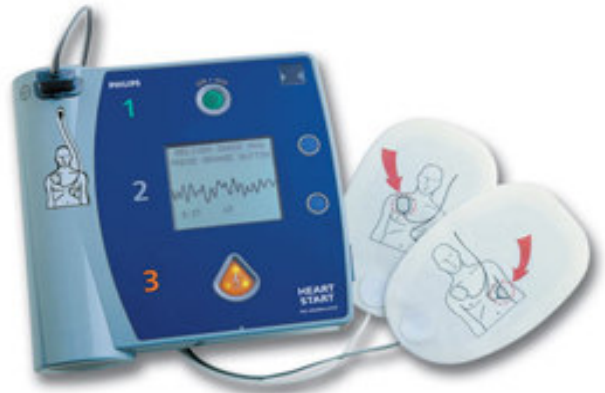
- ❖ Philips has received reports of a memory chip failure in a small number of model FR2+ units manufactured in 2007 and early 2008. These reported failures were detected during routine self-tests, not during emergency use of the AED.
- ❖ Failure of this chip could render the AED inoperable and prevent it from delivering therapy when indicated, although Philips has received no reports of injury associated with this chip failure.

- ❖ Survey your location and identify if you have any AED FR2+ models that meet the criteria described in the communication issued by Phillips. Confirm this by going to the website <http://www.healthcare.philips.com/us/products/resuscitation/products/fr2plus/action.wpd>. See "Serial Number Search" in the right-hand column.
- ❖ If you have a confirmed affected FR2+ unit, follow the instructions on the website for replacing the unit. Philips will replace the affected AED at no charge.
- ❖ When you receive the new FRx unit, add it to your site preventive maintenance system and delete the old unit.

**Note:** Where applicable, specify your replacement model as the **HeartStart FRx**, **not** the refurbished FR2+. See "Choose Your Replacement" in the right-hand column of the website. A complete description of the FRx can be found at [www.healthcare.philips.com/us\\_en/products/resuscitation/products/FRx/index.wpd](http://www.healthcare.philips.com/us_en/products/resuscitation/products/FRx/index.wpd)
