Shell EPW Wells HSE Early Learning Bulletin

Fountain No: 138974 **Location:** Rockies WS **Date:** 16 August 2007 **Risk Ranking:** Actual - Level 0, Potential B4 People

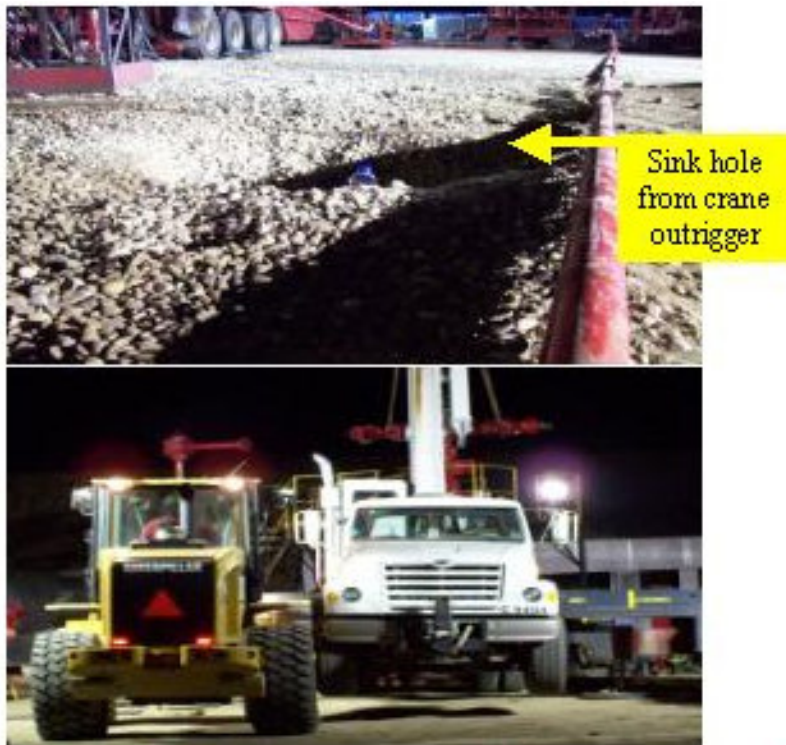
What happened: Coil tubing had finished drill-out operations on the first of two wells. After coil tubing rigged down, a boom truck crane was being used to move a flow-cross and safety BOP from well 1 to well 2. The wells are 6 ft apart and the weight of the equipment lifted was approximately 13,000 lb. During the lift, with the flow-cross and BOP approximately 1 ft above well 2, the crane outrigger and pad began to sink into the ground (~ 18 in.). The unexpected movement of the crane resulted in the flange on the flow cross coming to rest partially on the framework of the frac stand and the well flange. After the load was stabilized, a job procedure was drafted to secure and move the load with another crane. No injuries to personnel or damage to equipment occurred as a result of the incident.

- Compaction of soil was inadequate. Sink hole occurred in area where a flow line had previously been installed.
- Include identification of flow line routes or other prior excavations in lift plans.
- Consider use of larger diameter jack mats in areas of known excavations.
- Consider use of larger cranes (boom reach) to increase distance between well related excavations and crane operations.
