Shell EPA Wells HSE Early Learning Bulletin

Fountain No: 139211

Location: SMEP

Date: 20 Aug 2007

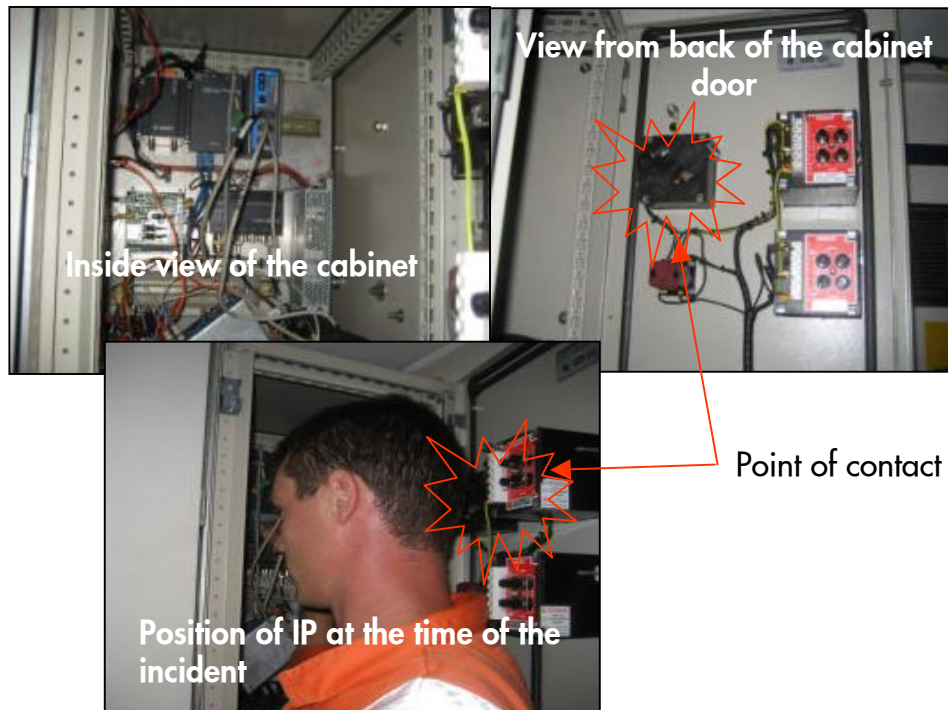
The door of the cabinet could only be opened approx. 75 degrees due to space constraints, causing very limited access to the interior of the cabinet. The inside of the cabinet door contains the 220 V and 440V electrical circuits / breakers. These were not shielded off.

As the IP was working on the fibre optic cables (which are positioned relatively high up inside the cabinet), he was holding on with his left hand to a connector, while with his right hand he was changing out / shifting fibre optic cables. The IP had taken off his helmet due to limited work space (narrow cabinet and limited access). While in this position, the back of his head came in contact with the exposed live terminal of the voltage meter located inside of the cabinet door. As a result, he got an electric shock.

- Suboptimal design of electrical cabinet:
 - Mix of instrumentation and high voltage equipment
 - No protection cover over live contact points
- Equipment was not commissioned and tested prior to load out offshore
- Lack of controls to manage this complex project
