Shell EPW Wells HSE Learning Bulletin

Fountain No: 139708 **Location:** GOM **Date:** 8/26/07 **Risk Ranking:** Actual - 0 Asset; Potential - D-3 People

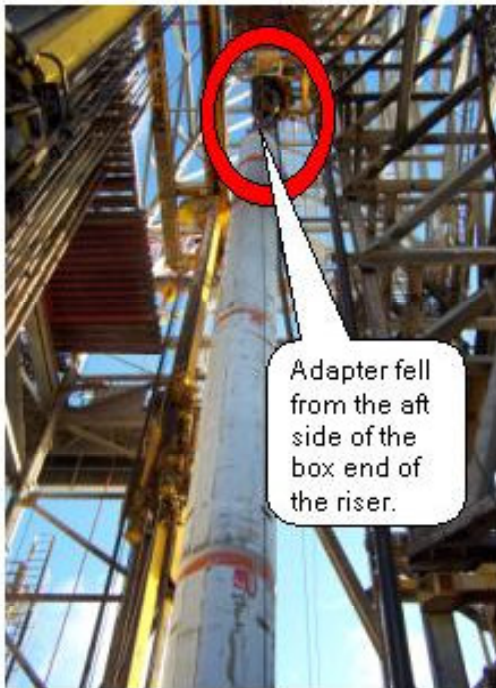
What Happened: NM-DROPPED OBJECT FROM HEIGHT. While running drilling riser, a floatation adapter stop plate (thrust plate) weighting 5.5 pounds fell approximately 90 feet and landed on port forward section of rig floor. No injuries to employees or damage to other equipment was incurred. The operation was suspended and a safety stand-down held with crews. Initial indications are that the adapter was not properly secured

- The thrust plate was not recognized as a potential dropped object hazard and not included in the pre-job hazard analysis.
- No provisions for “pre-lift” visual inspection of the adaptors and associated securing bolts had been implemented.
- The adapter had been previously modified and an MOC had not been completed.
- Preventative maintenance for the thrust adapters was not implemented.
