Shell EPW Wells HSE Early Learning Bulletin

Fountain No: 136781 Location: GOM Date: 07/22/2007 Risk Ranking: Actual – Level 1, Potential – D2 Med

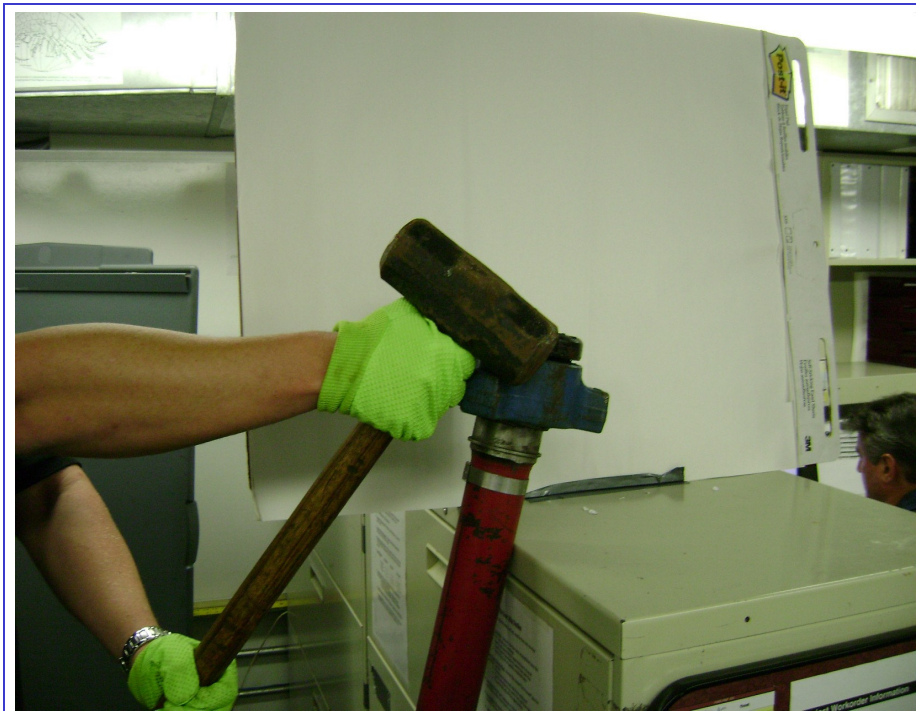
What happened: MTC-PINCHED FINGER WHILE USING HAMMER. Nitrogen Crew had completed displacing annulus on assigned well. During rig down of piping, the injured person used a 6 lb. sledge hammer to loosen the union on a 1" chocksan. The hammer glanced off the hammer union and pinched his right index finger against the 1" piping, resulting in a small fracture of the fingertip. The employee was wearing gloves at the time of the incident.

- Recommend use of a sliding sledge or other alternative tool instead of using a sledgehammer on unions.
- 4 lb hammer had a loose head so the employee used an 6 lb hammer which was too big for the task.
- Incorrect hand position on sledgehammer due to
 - Lack of adequate access to union
 - Use of the larger hammer
 - Interference with associated piping
- Fatigue & high temperatures also a contributing factor.
